SUBJECT: Fire Station Evaluation Study  
Clinton Corners, N.Y.

## II. BUILDING INVENTORY:

## V. EXISTING STATION 1 PHYSICAL CONDITIONS:

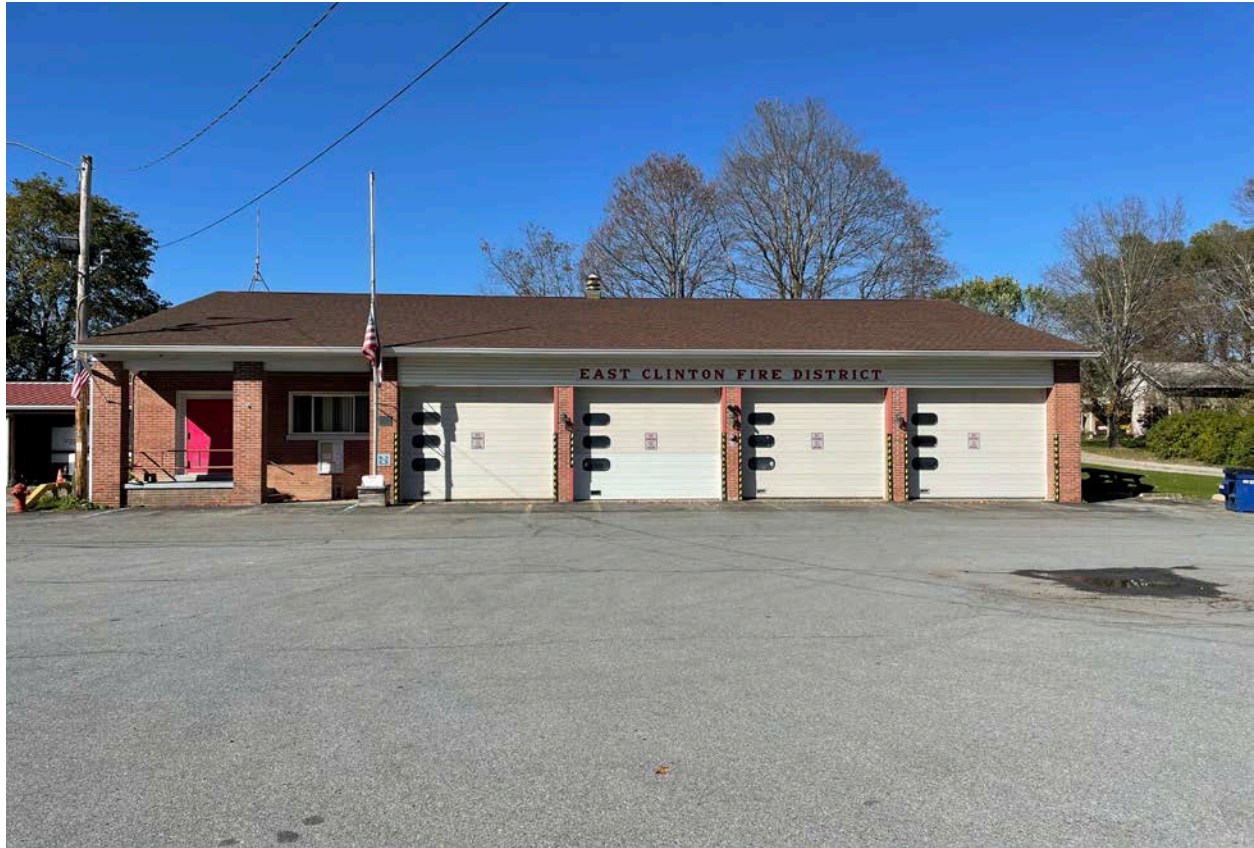
East Clinton Fire Station – 9 Firehouse Lane

The East Clinton Volunteer Fire Department headquarters is located the Hamlet of Clinton Corners. This is the only fire station for the Fire District. This building is located on the end of the road at 9 Firehouse Lane on a lot that is approximately .72 acres. The structure is a single-story concrete masonry block (CMU) and steel building. The fire station was erected in 1957 and was built around the original platform of the Clinton Corners train station which ran through the property from 1880 and was disbanded in 1938. The fire station's original design was a single-story structure using CMU walls, structural steel & bar joists roof framing and cementitious panel boards for roof decking, covered by a ballasted roof system. In 1980, the ballasted roof was in need of replacement. It was decided to add a wood gable roof truss with asphalt shingles and span the building from front to rear. This area is now used for storage and is accessed by a wooden stair located at the rear of the building. In 1990, the pole barn addition was added to the south side of the station. It is assumed the septic system is located on the north side of the building. The water service comes into the building on the south side of the men's toilet room. The current condition of the building is fair and has served the fire district well for over 65 years.

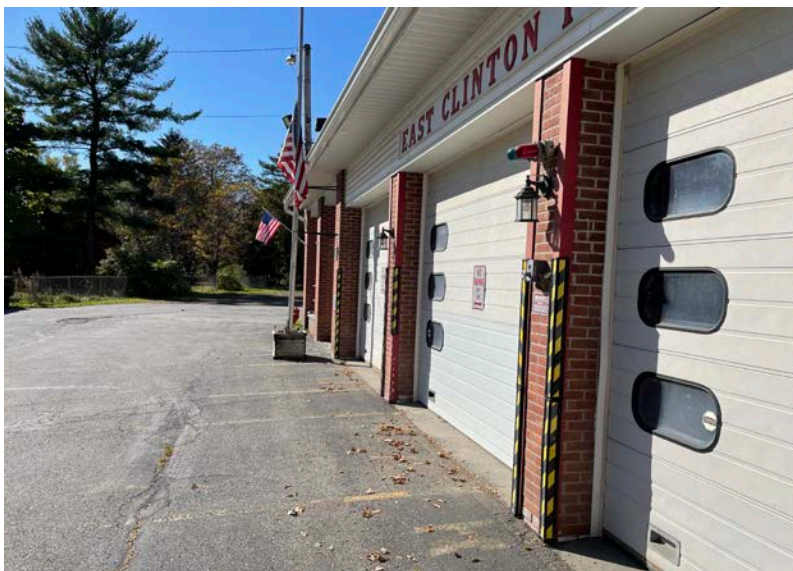
1. The current overhead door widths (11'-11") and heights (10'-0") are very tight for modern apparatus (it appears less than 3-inch clearance in some cases to obstructions) The industry standard for fire stations are specified with 12' to 14' wide or 12' to 14' overhead doors.

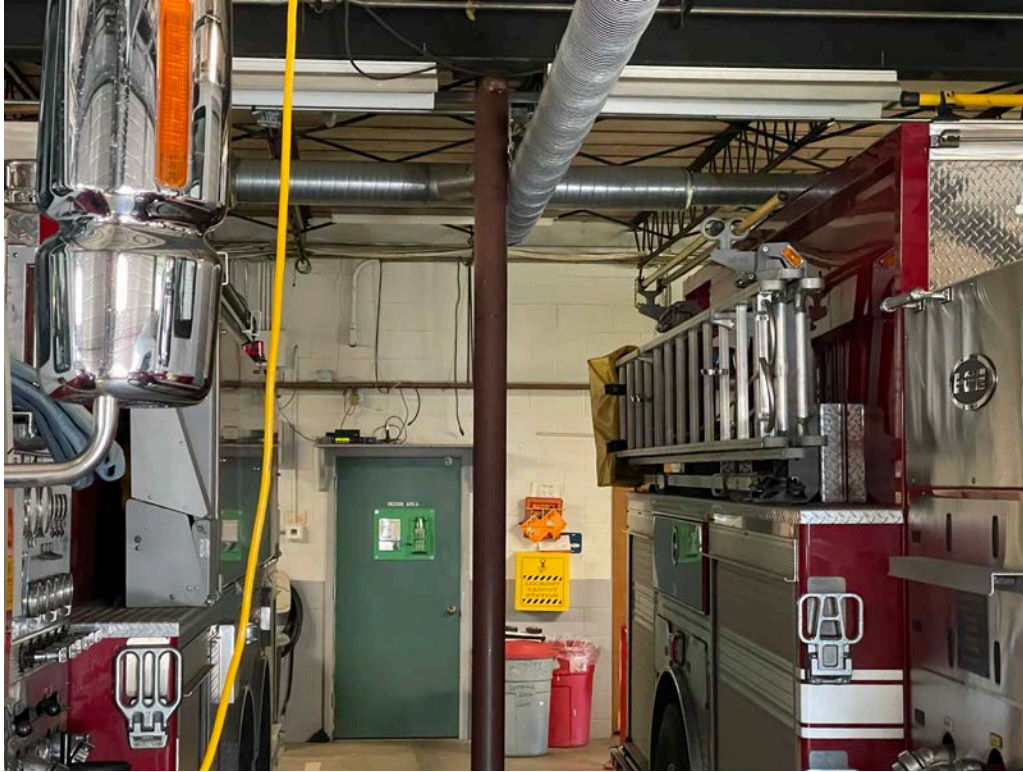
2. There is no significant headroom above the equipment. This limits the District's ability to acquire modern equipment since most of the newer equipment is based on a minimum door height of 12' to 14'.

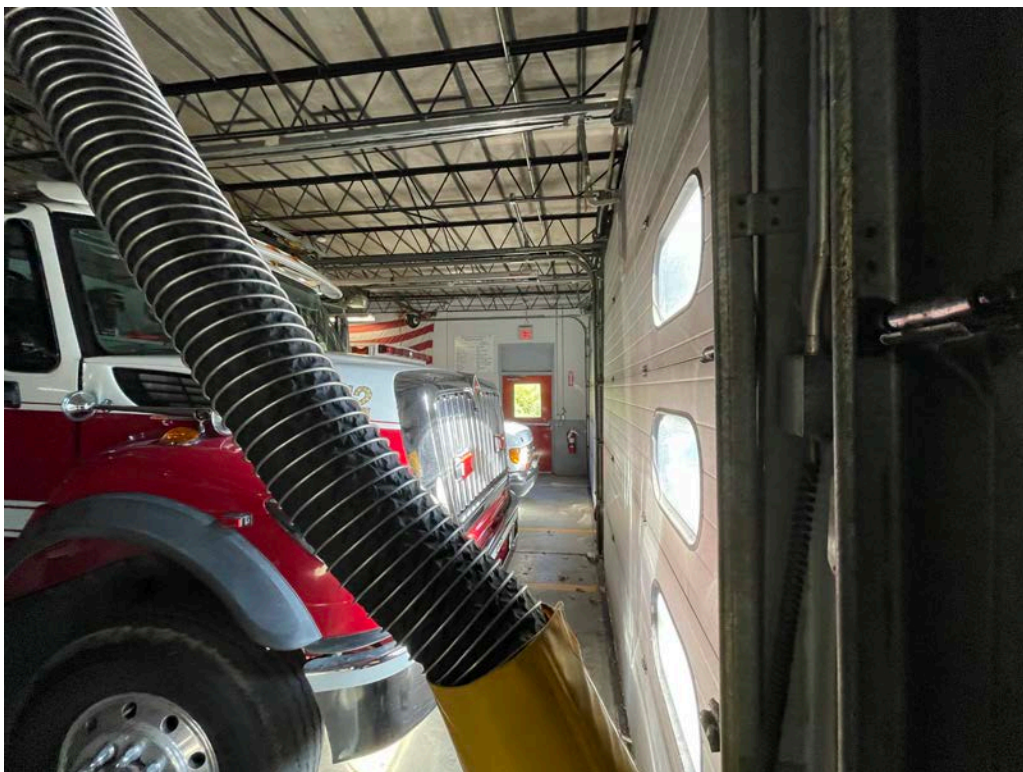
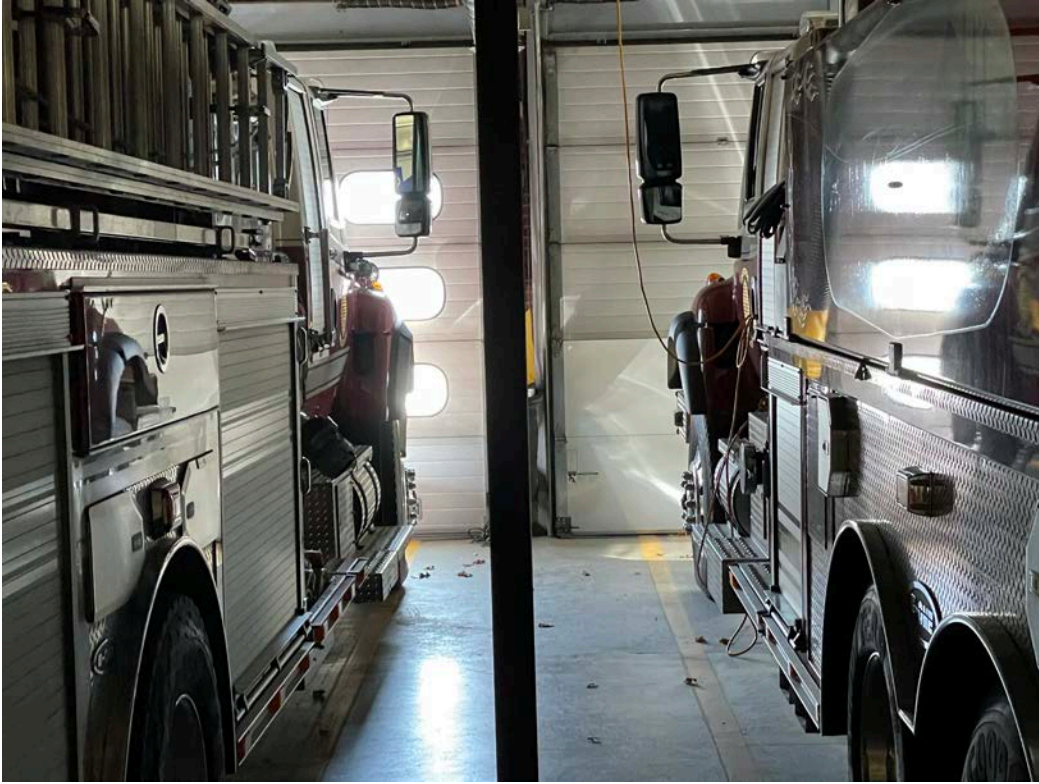
3. There is a clear lack of clearance around all apparatus for maintenance. NFPA recommends a 5 ft working area around all sides of the apparatus.

Lack of clearance around apparatus

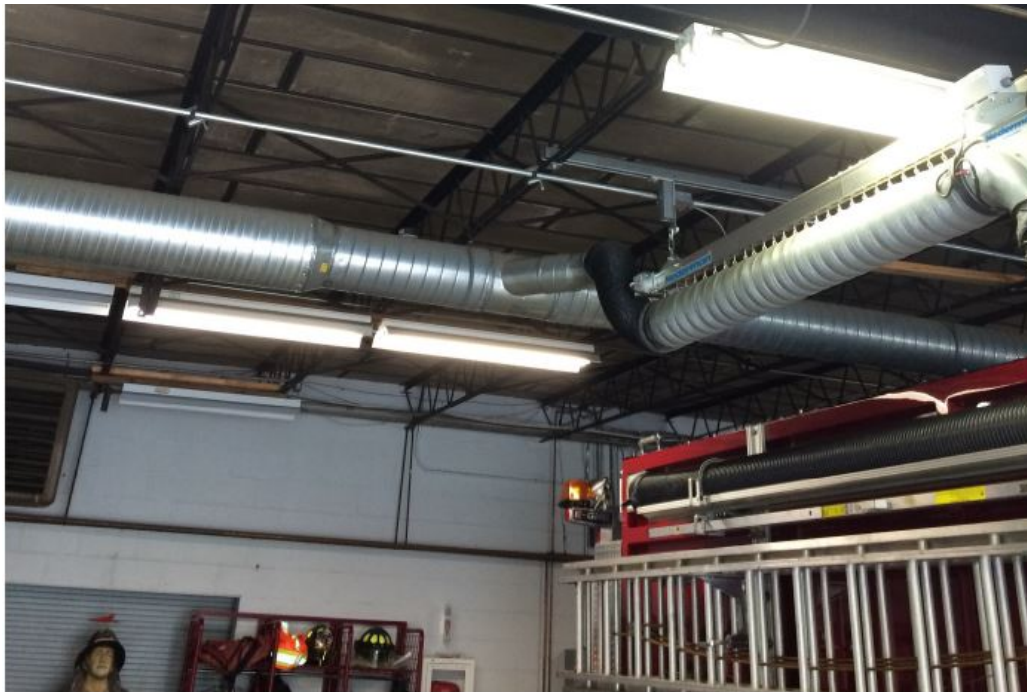
4. The ceiling and bar joist structure above the apparatus bays is quite low for working over a piece of apparatus.

Lack of headroom to access top of hose bed.

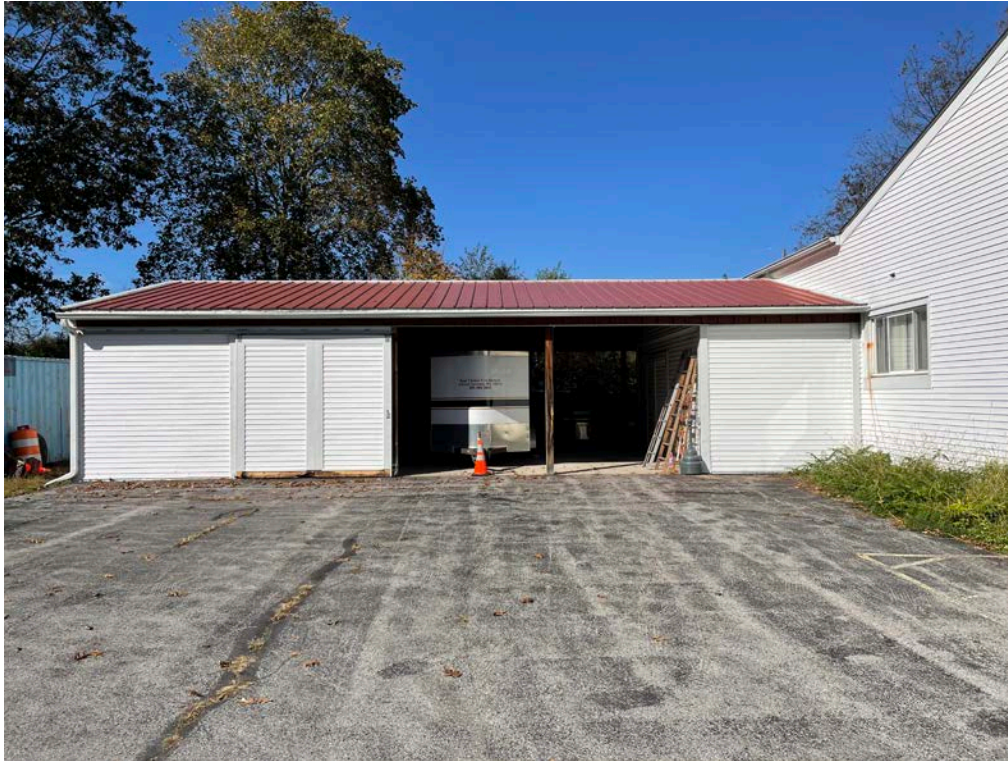
5. With only (4) apparatus bays and (7) Emergency Vehicles, Vehicles like the Haz-Mat Trailer are sitting in the Pole Barn and need to have electric heaters inside to keep vital equipment warm. The smaller vehicles are double stacked in the bays. NFPA allows stacked vehicles when there are overhead doors on the front and rear of the bay.

Haz-Mat Trailer

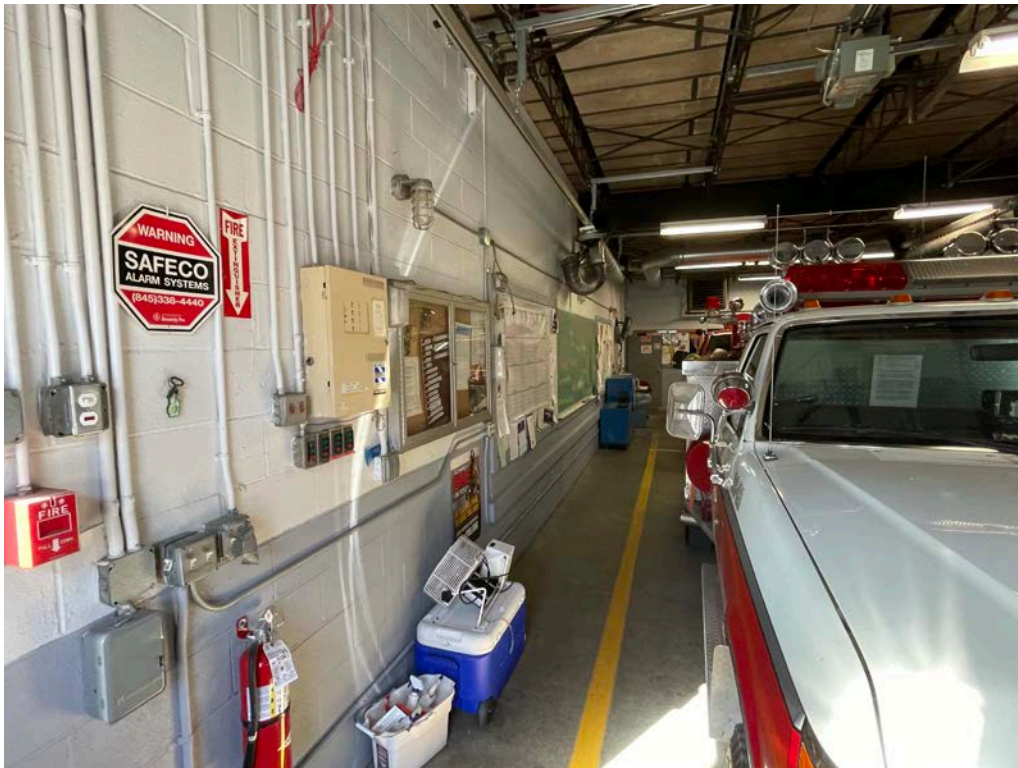
Mini Attack and Brush Truck stacked tandem.

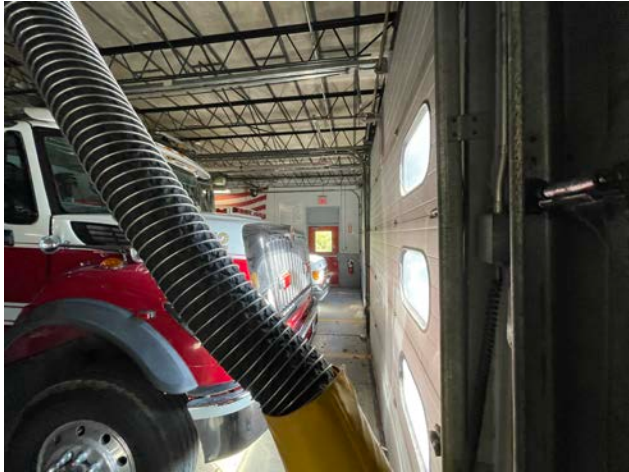
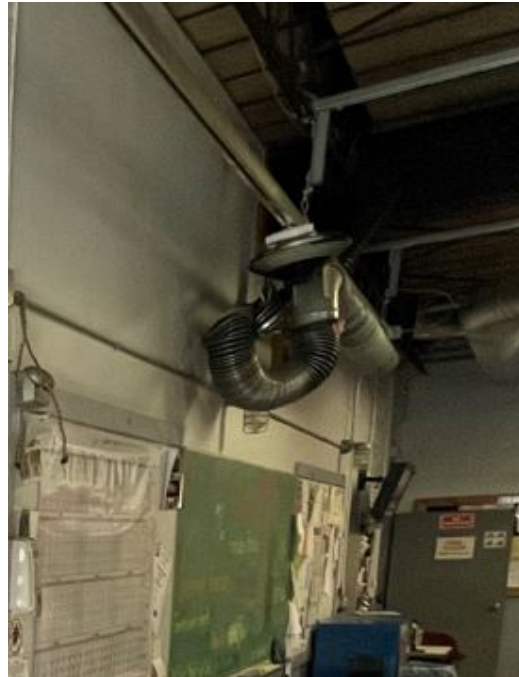
6. There is a Nederman Vehicle Exhaust System that is not being utilized as per NFPA 1500

Lack of Tail Pipe Exhaust Usage

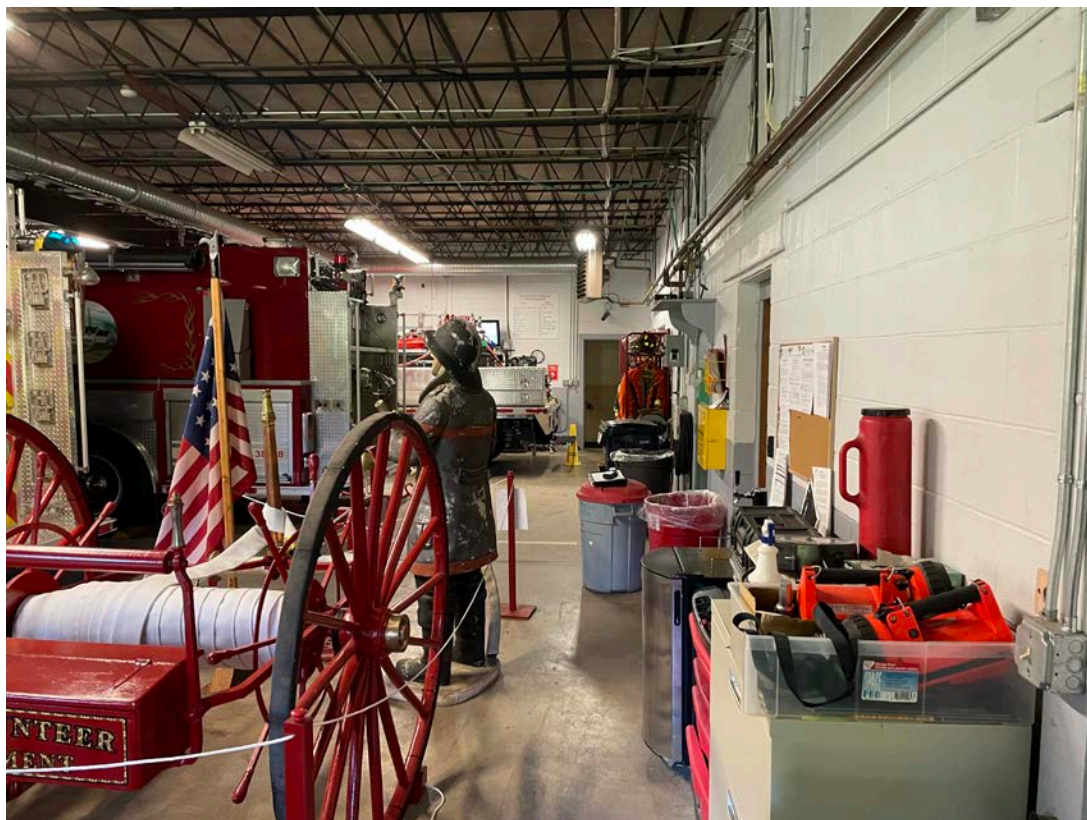
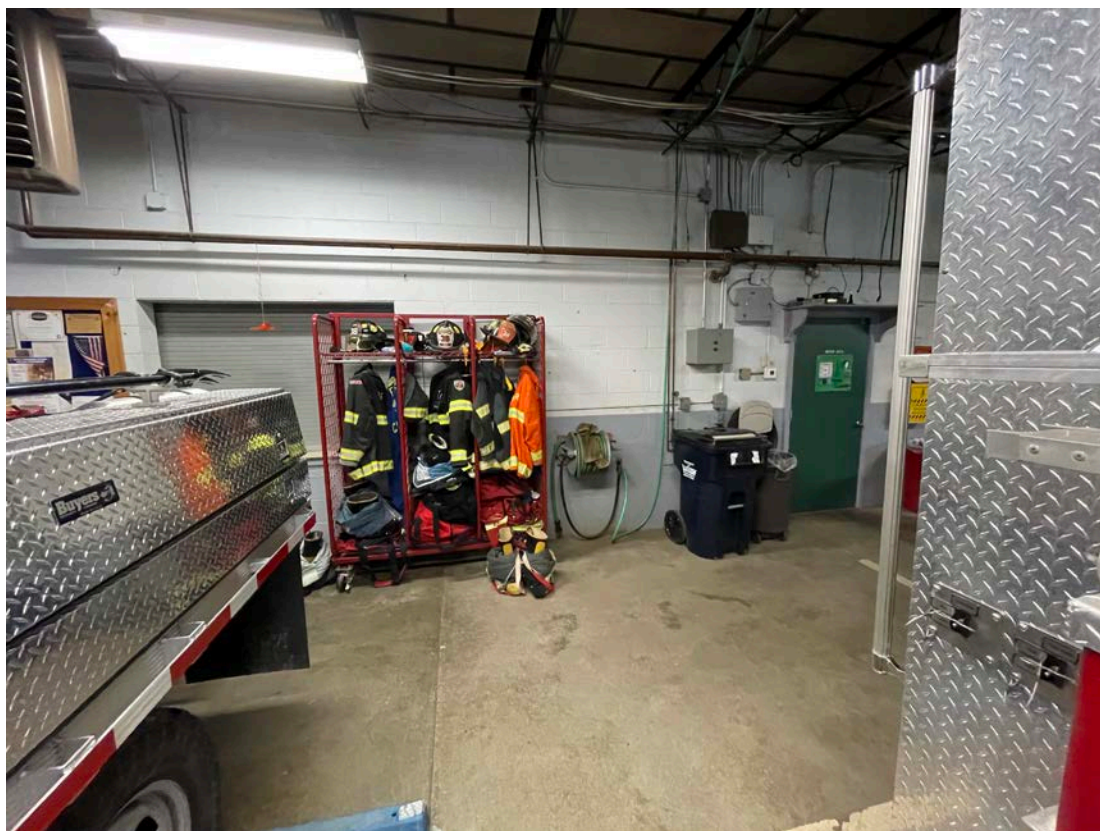
7. Lack of Support Rooms add to clutter in the Apparatus Bay.

The only Gear Rack in the Fire Station

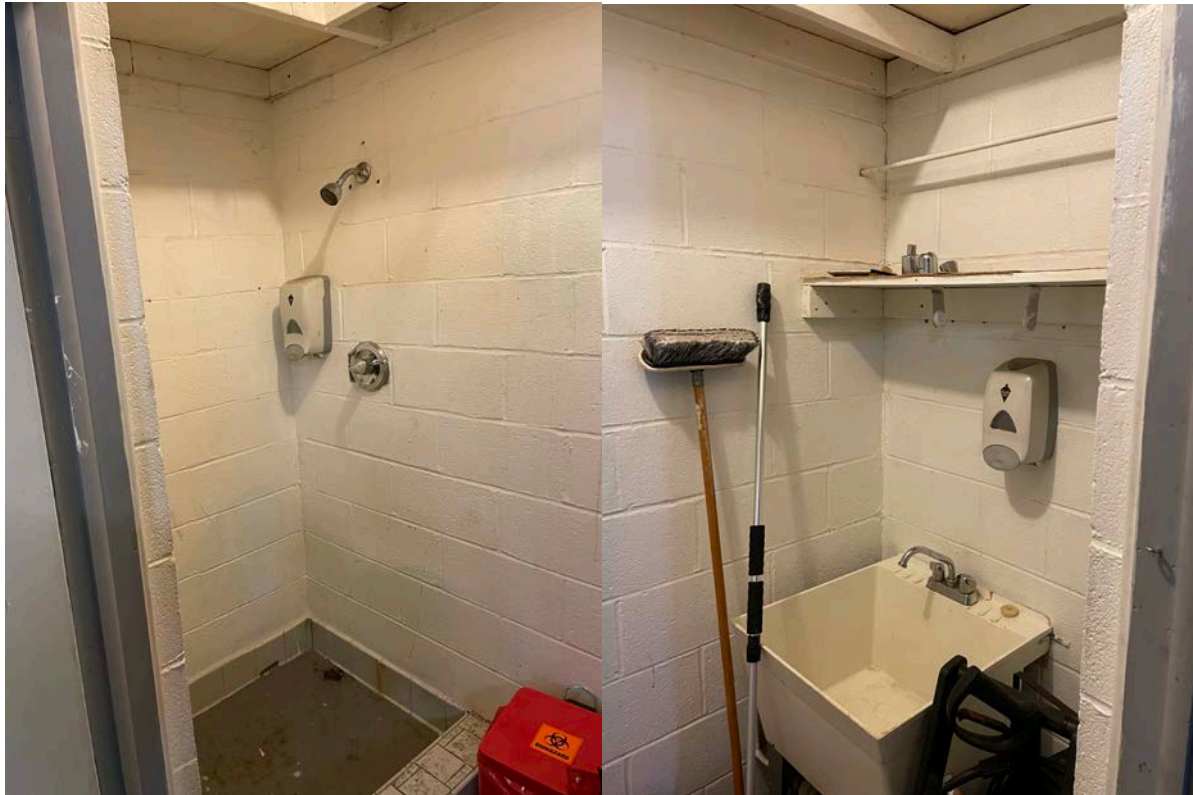
8. There is a lack of a Decon and equipment clean up area. The shower located in the custodial closet is ok for general use, but a true Decon shower should be accessible from the station's exterior.

Custodial Closet Shower

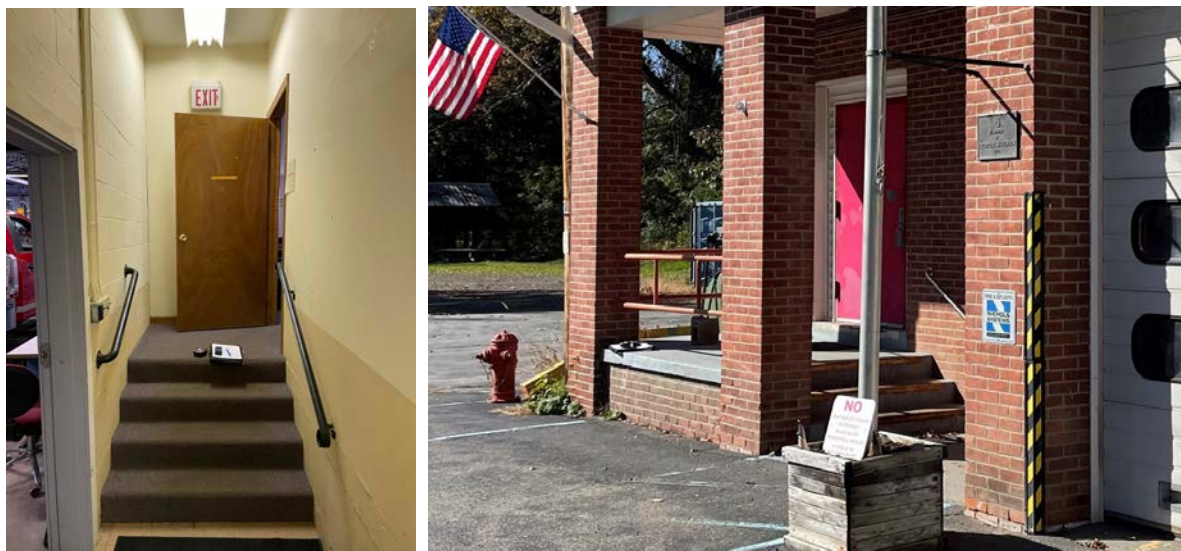
9. There is a lack of a gear washing area. (OSHA Required)  
10. There is a lack of accessibility to the Meeting Room (ADA)

No ADA Compliant Ramps or Lifts to Reach the Meeting Room Floor.

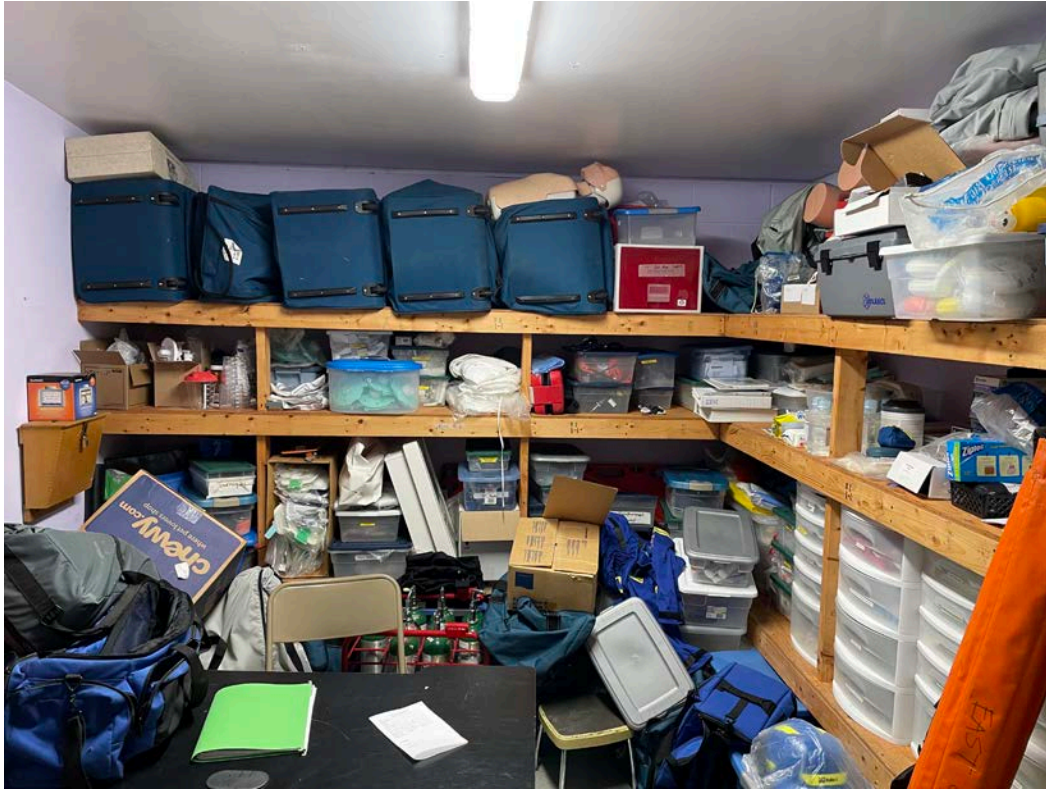
11. There is no apparent readily accessible hose storage in the apparatus room. It's outside under the pole barn
12. There is a general lack of Firematic and EMS Storage though out the building.

EMS and Firematic Storage

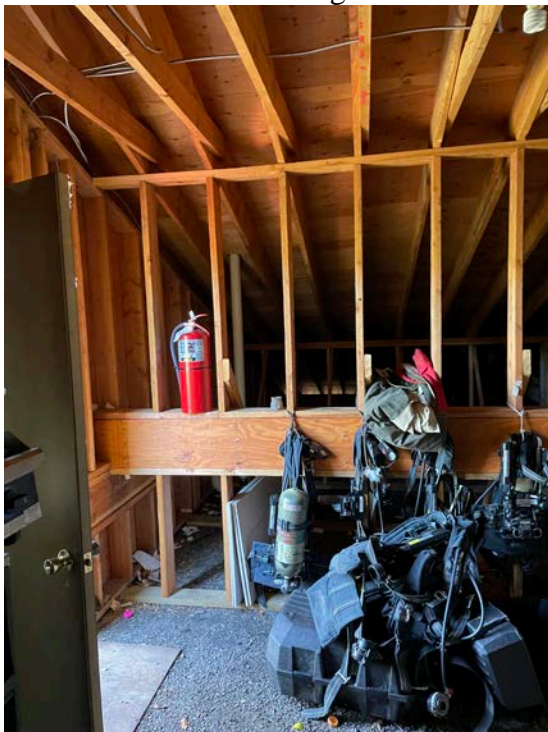
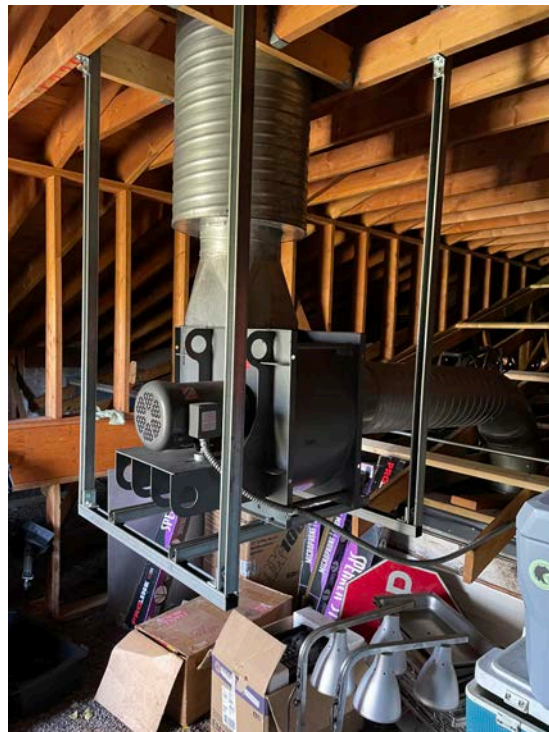
Equipment in Non-Climate Controlled Attic Storage Space

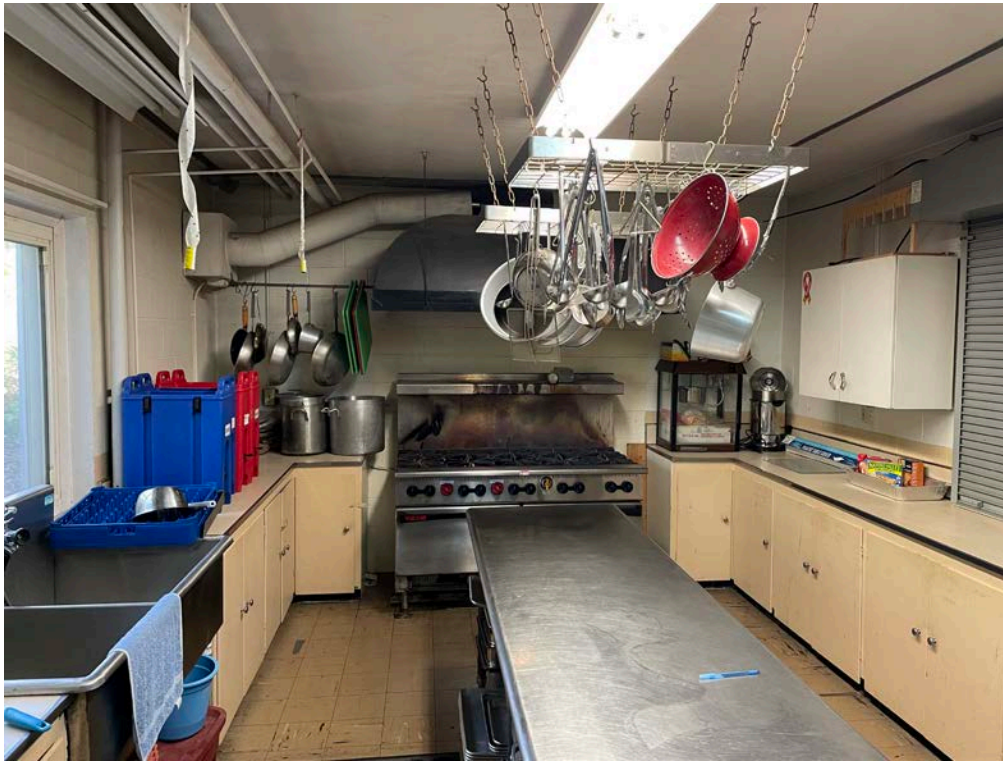
13. The kitchen stove is not equipped with a code compliant hood / exhaust and Ansul System.  
Lack of makeup air.

Kitchen Stove and Hood

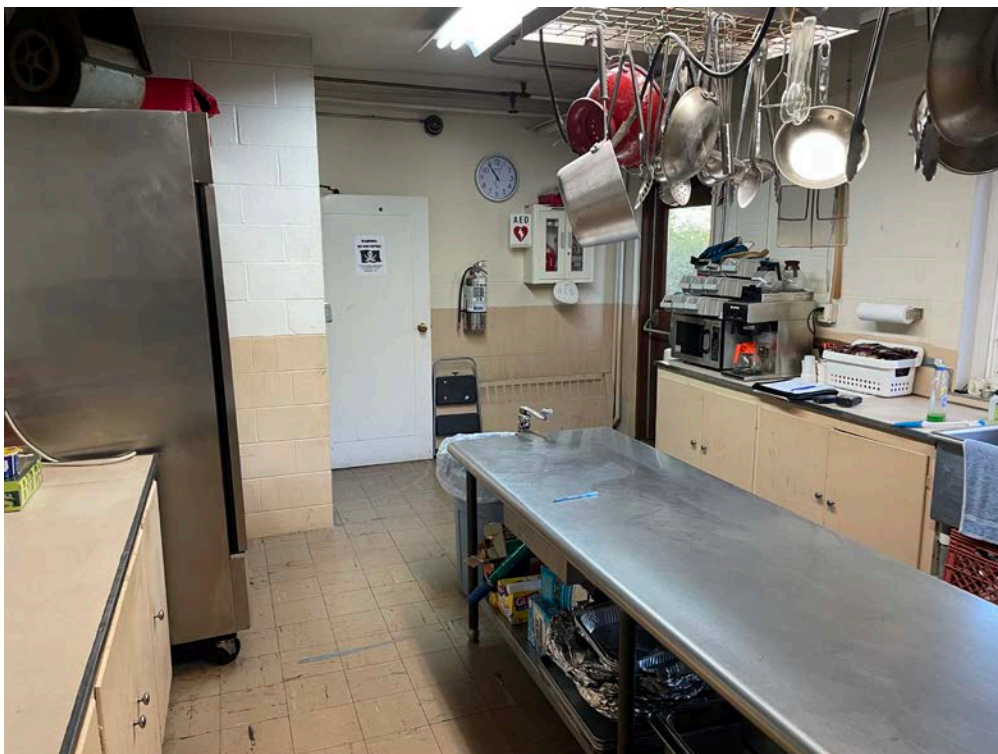
14. The Kitchen floor has 9x9 asbestos tile.

Asbestos Floor Tile

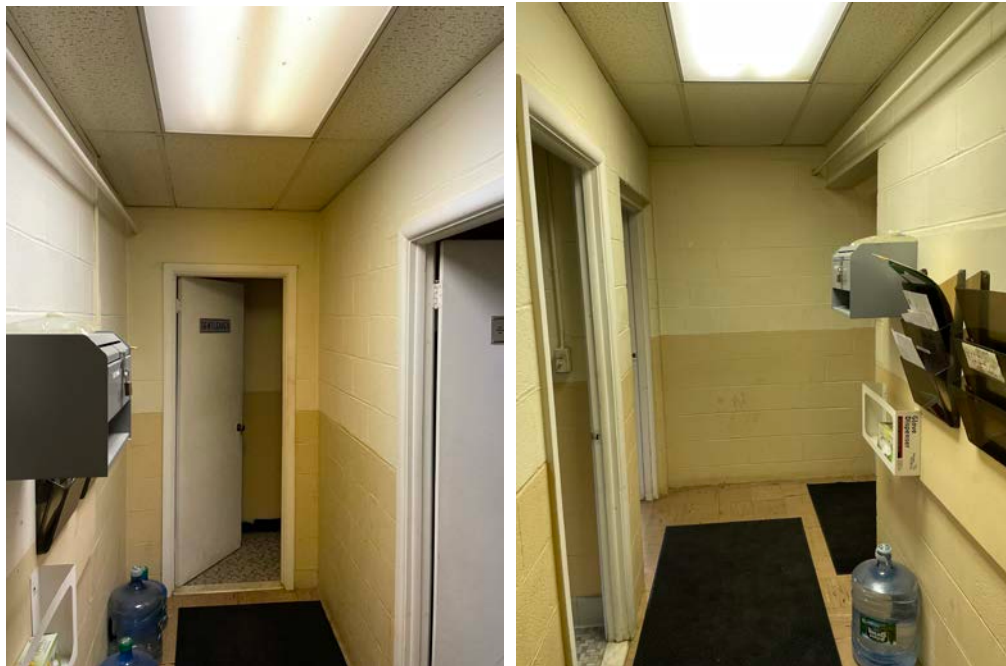
15. The corridor to the Kitchen and Toilet Rooms does not meet ADA Clearances at the door approaches. Corridor widths and stair widths are not up to current standards for egress. (less than 5'-0")

Corridor Clearances

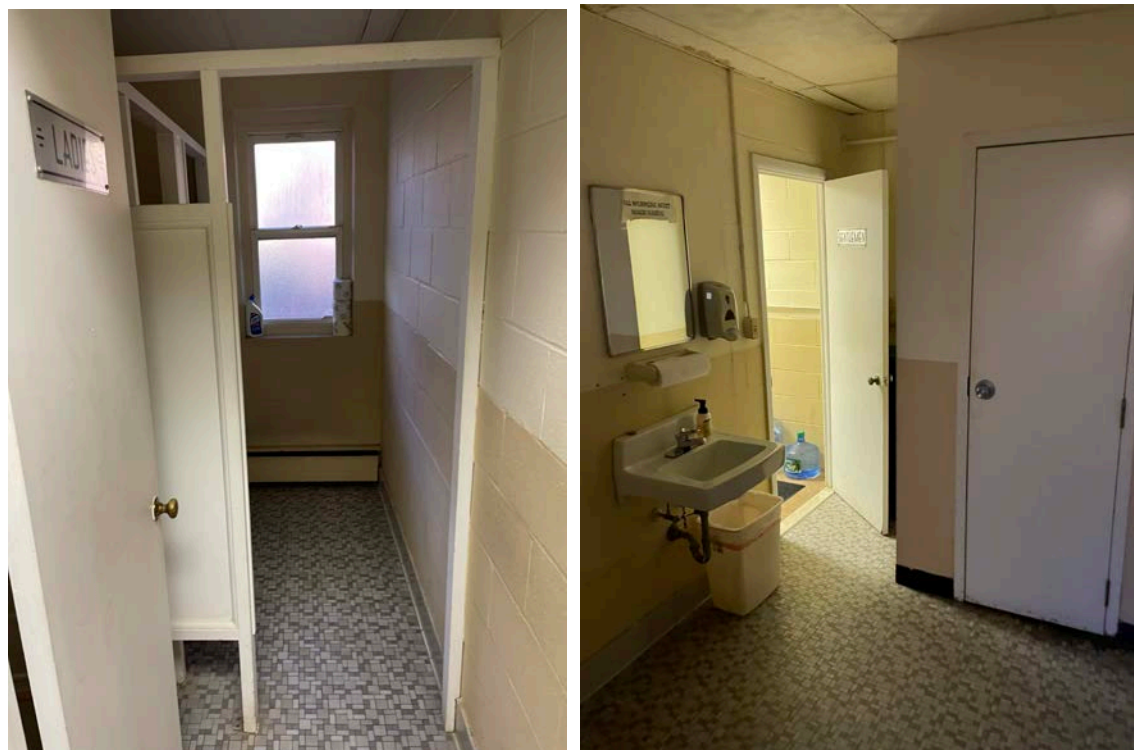
16. Both of the restrooms do not meet current ADA requirements for access and fixture approaches, along with a lack of ADA grab bars. The entrance doors into each of the restrooms measure only 2'-4". The door to the Men's toilet room does not open 90 degrees. Current requirements are 3'-0".

ADA Clearance issues in Toilet Rooms

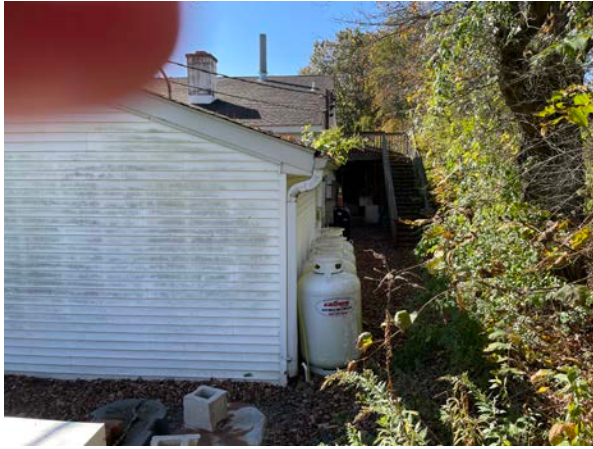
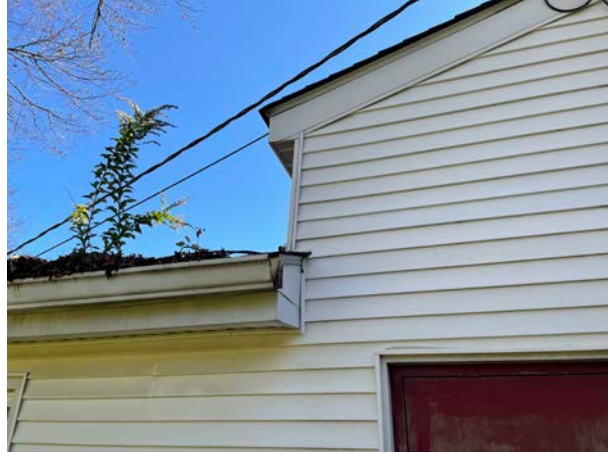
17. There is a general lack of insulation throughout the building making it energy inefficient
18. The mechanical systems are antiquated and inefficient. (No air conditioning or continuous ventilation to occupied spaces.)
19. The equipment in the electrical room is also outdated and should be updated. There is an electrical service wire lying on the roof on the north end of the building.

Low hanging service wire to the Weather Head / Gutter Clutter

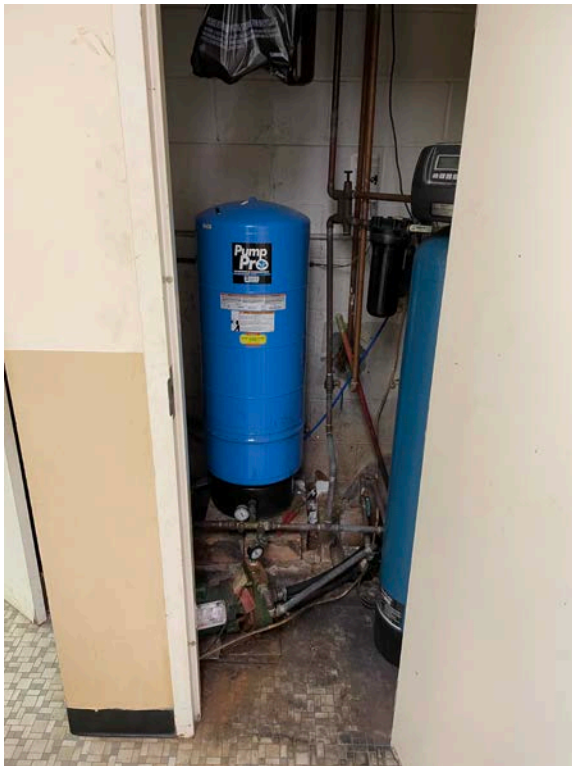
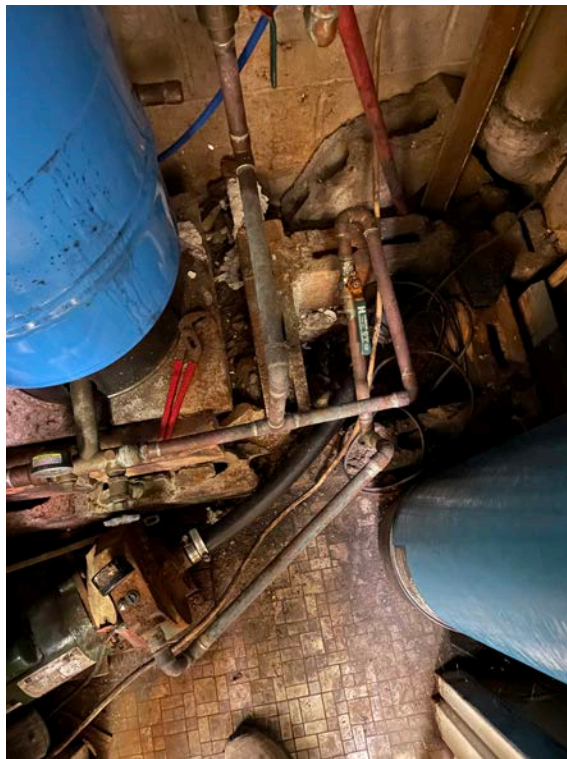
20. There is a jet well pump in the water treatment closet. A jet pump is indicative that there is a shallow well. With the number of water bottles present, does the well water have an issue for public consumption? How does this effect the ice machine and Kitchen use?

Water Treatment & Pump

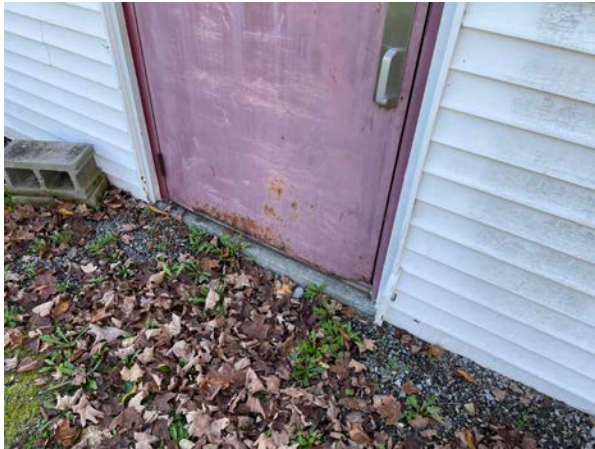
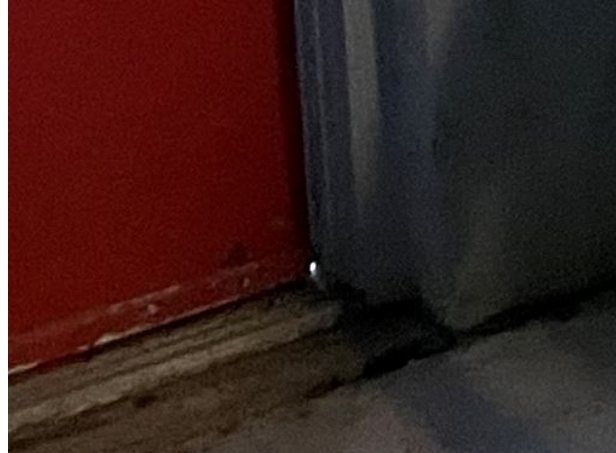
22. Some of the existing vinyl replacement windows have lost their seals.
23. Daylight can be seen in the weather stripping and seals on the hollow metal doors. The north side hollow metal door has rot.

Door Rot

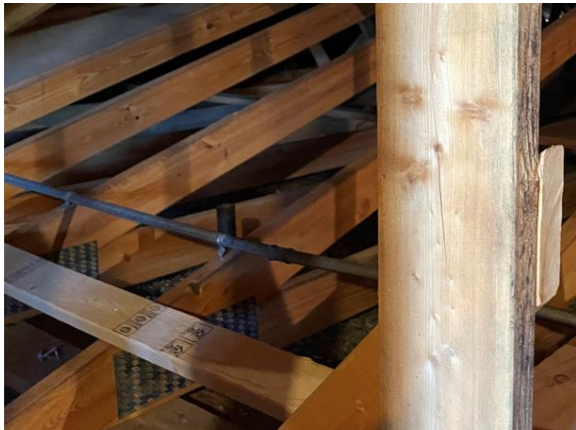
24. The wood roof truss over build appears structurally sound. There are some deficiencies in the design. Some vent piping did not continue through the wood roof deck. There is the lack of a smoke stop for 3,000 s.f. of attic space to help minimize smoke and flame spread across the full attic. No attic insulation was installed. The attic storage room (S-2 Classification) over the kitchen and toilet room (B Classification) does not meet code. The code requires a 2-hour separation between the S-2 & the B Occupancy in Non-Sprinklered Buildings.

Vent pipe terminated in the attic.

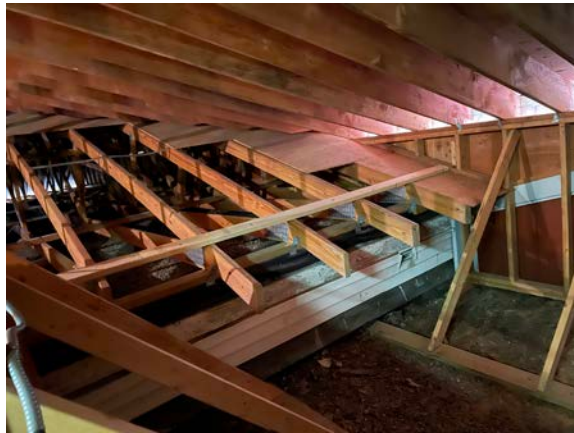
S-2 over B Occupancy

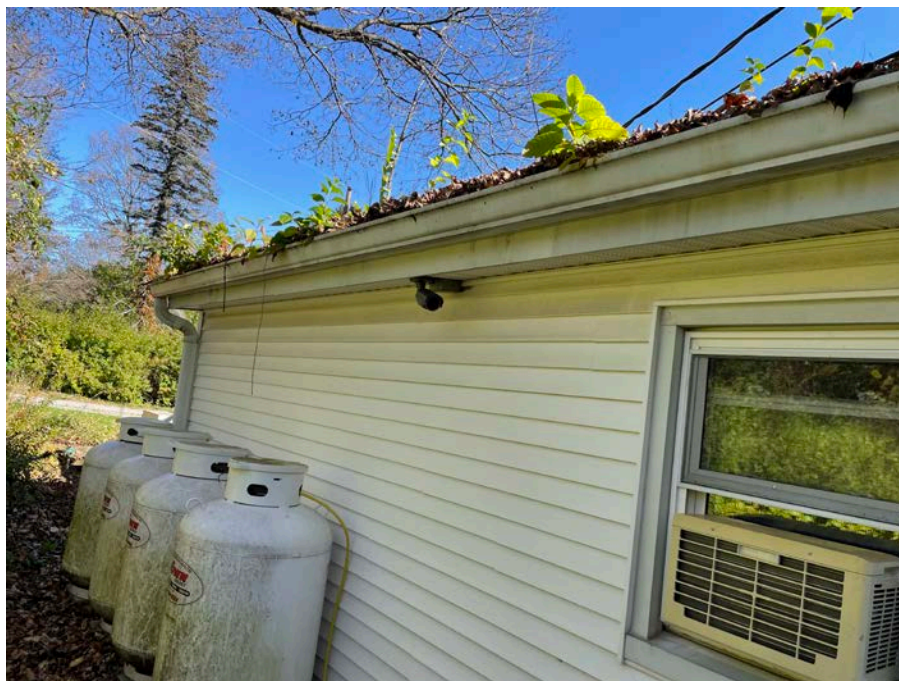
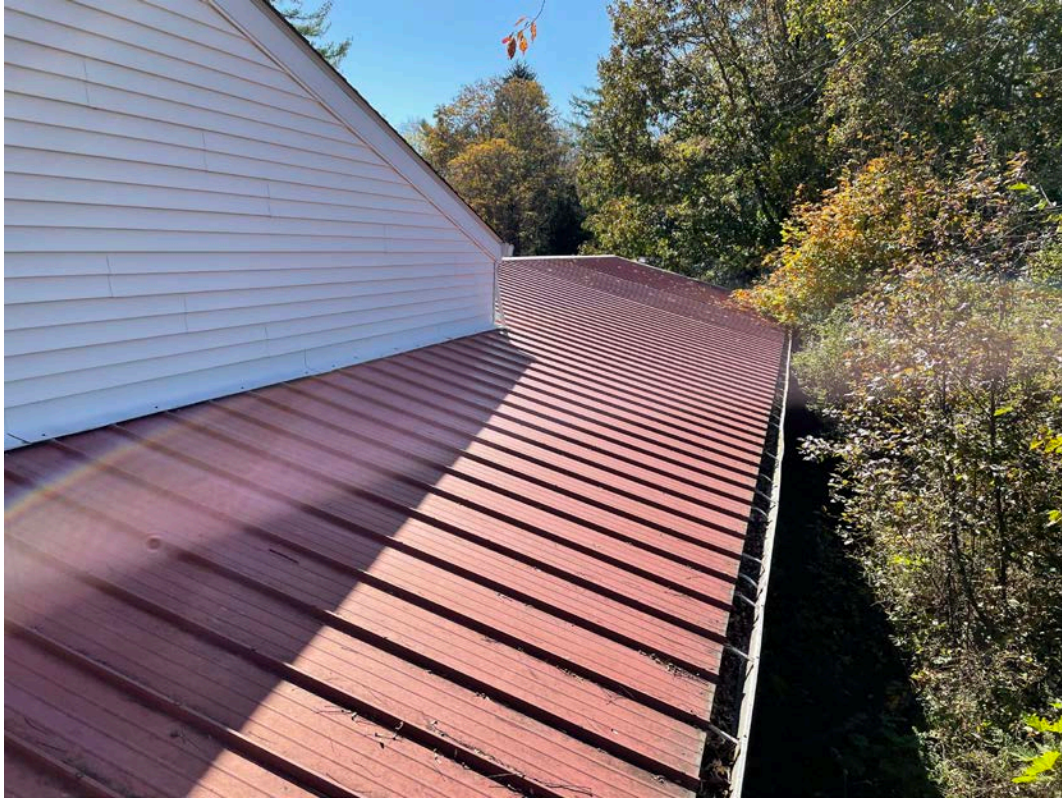
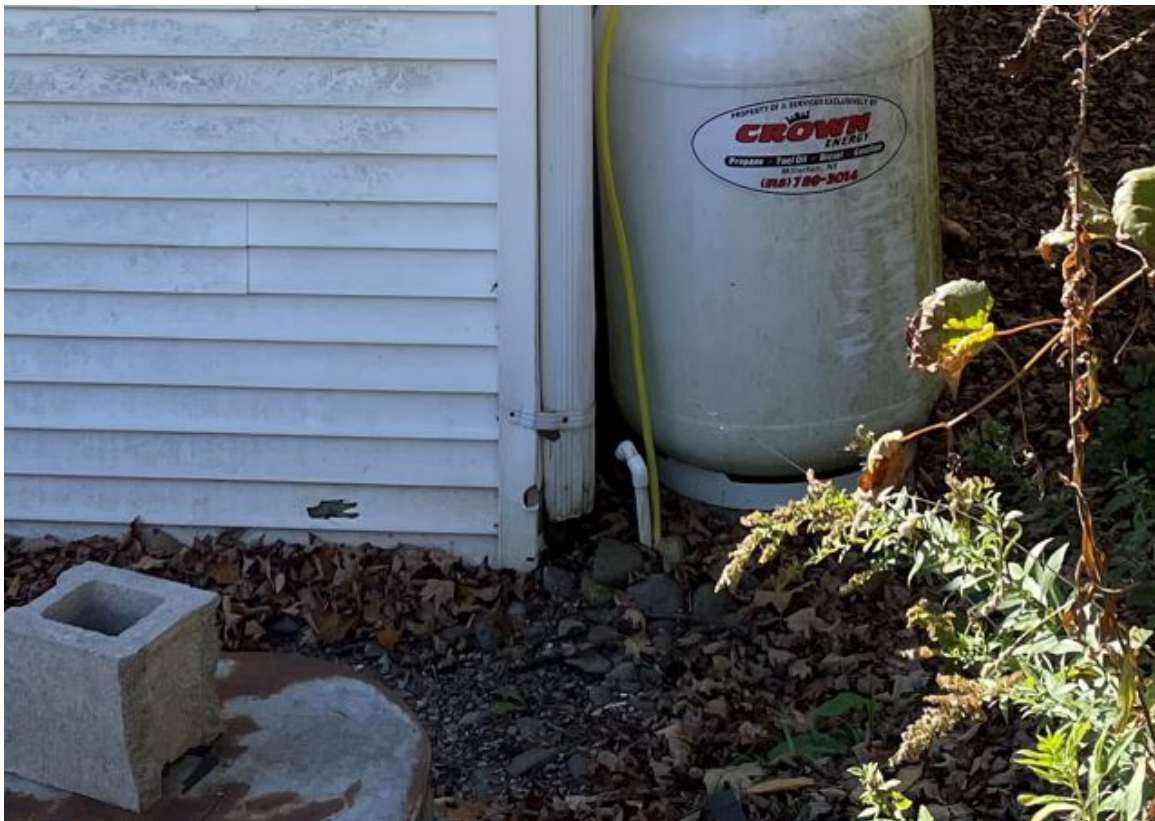
25. The exterior gutter and leader system should be replaced. Non properly draining gutters will lead to long term wall and foundation damage around the sides and rear of the building.

Gutters and Leaders
